## Jasmine Creek HOA

March 23, 2023

SUBJECT: Tree Risk Assessment

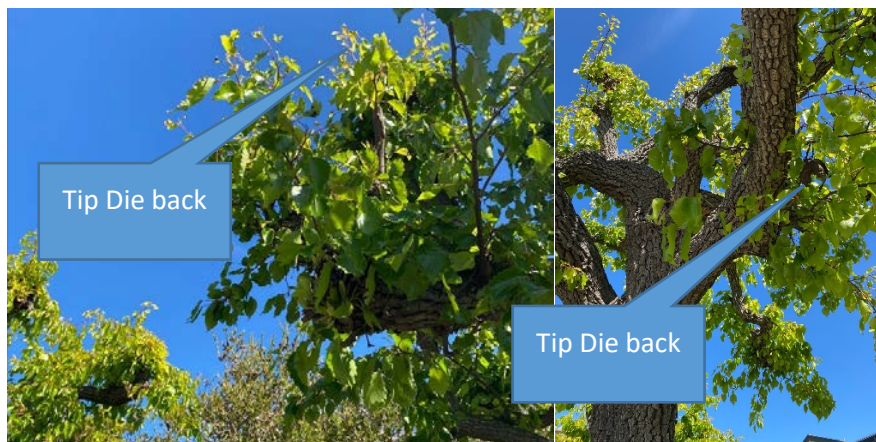
The Pear trees along the slope on Breakwater Dr, all have Fireblight is a highly infectious and widespread disease caused by the bacterium, Fireblight attacks blossoms, leaves, shoots, branches, fruit, and roots. This is a big problem agriculture, and starts by slightly sunken cankers, very common in this type of species. Because the homeowners' views are important massive reduction cuts are made to achieve the objective, not worth trading (Plant Heath Care) due to what remaining foliage is in the canopy, is secondary response growth (sucker twigs).

Massive reduction in cuts for views, eliminating is natural structural integrity for this type of species.

In conclusion, Pear trees along the slope of Breakwater Dr, recommendation to remove; also recommending no replacement trees - not warranted due to the views. Trees planted along the slope will always be subjected to being topped and or pollarded. Secondary issues are always a higher potential following that type of pruning. The remaining pears throughout the community are currently not showing visible signs of blight. The Pygmy palms, given the current lifespan and high target area, recommendation for removal. We will continue to monitor their status and if there is anything to report, it will be brought up to your management team. 25 Mainsail (Monitor), 34/32 White Water Dr (Recommend Removal), 20/22 Skysail Dr (No Action Needed).

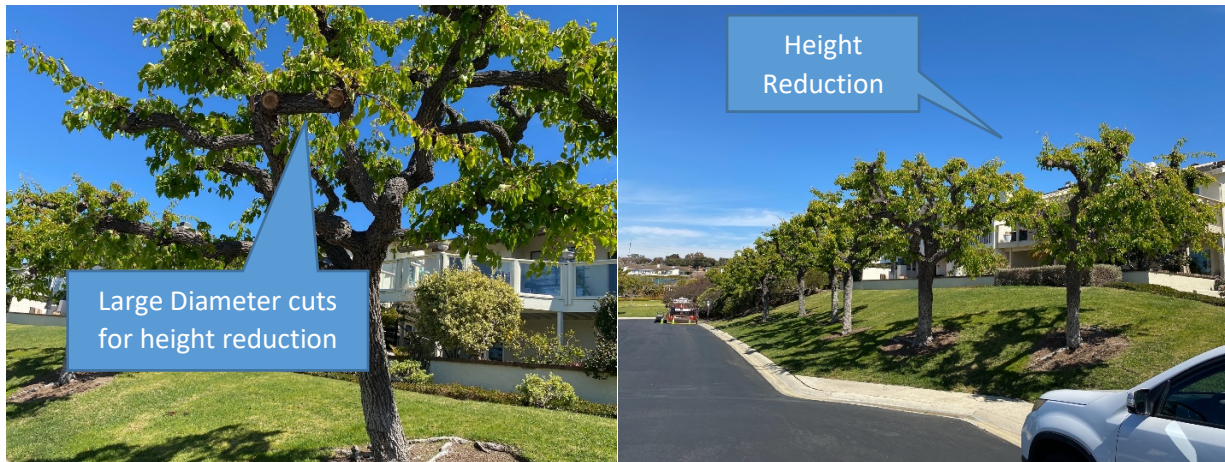
Given the age and current size of the trees (DBH), heavy reduction cuts essential for views, roots had to expand in response compensate for lost in foliage in the canopy, possible additional entry for fire blight throughout the tree vascular system. Cavity was also found near the root flare. Not sure how deep it goes. The concern is that it has not compartmentalized from the old wound, leaving the tree exposed to infection.

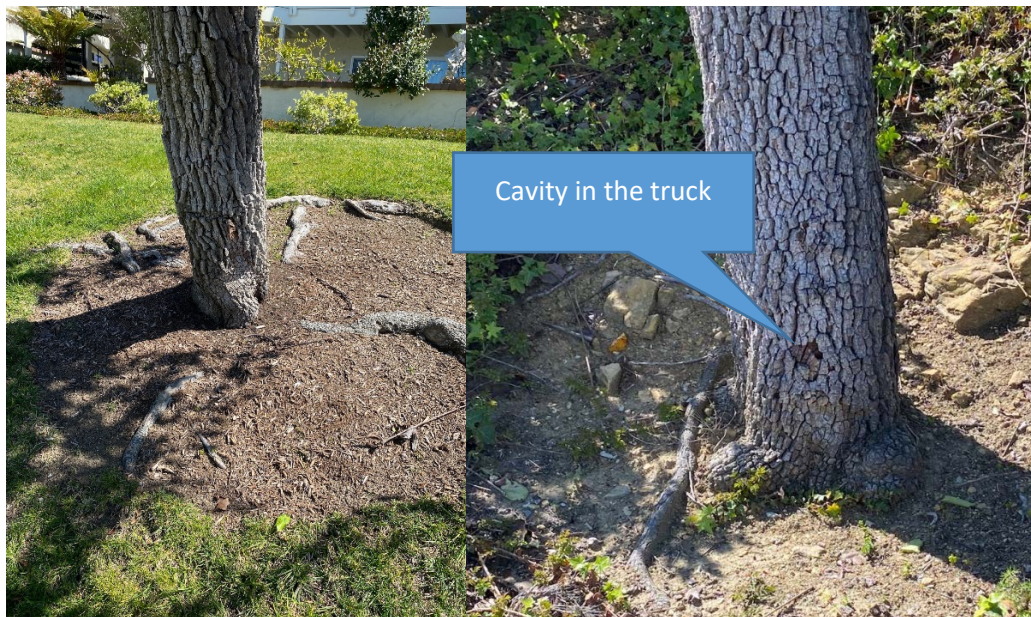
Pear along 25 Mainsail Dr. Monitor statutes, no visible signs of blight, although if cracks start to establish in the soil, recommendation for removal.

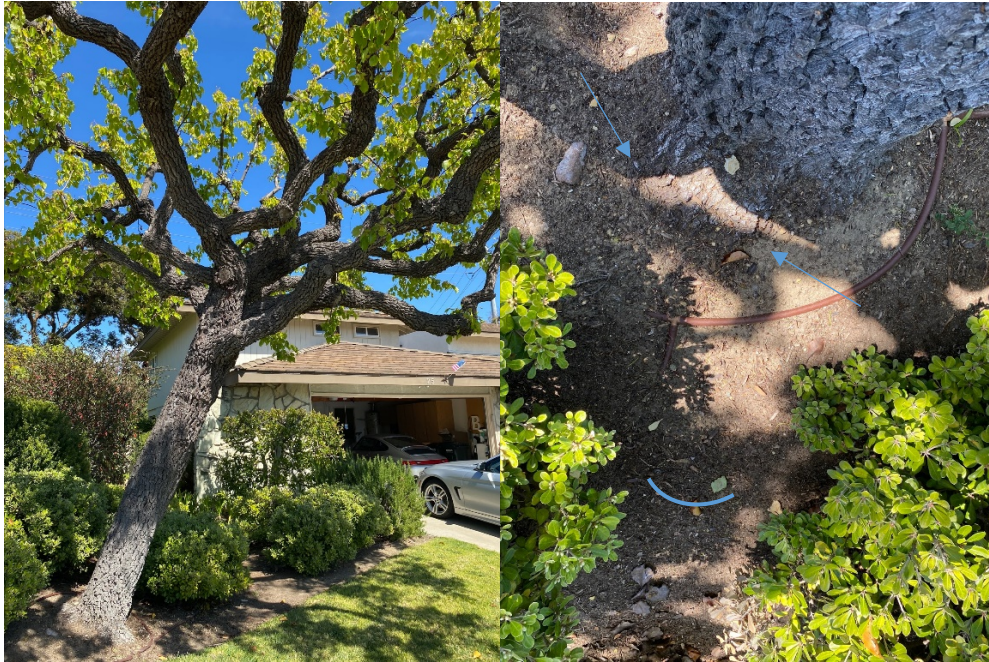
Pear in between 34/32 White Water Dr, has a heavy surfaced girdling root, no visible signs of blight, tree appears healthy. However, recommend removal because as the tree continues to grow, so will the trunk's girth (DBH), further choking the vascular system.

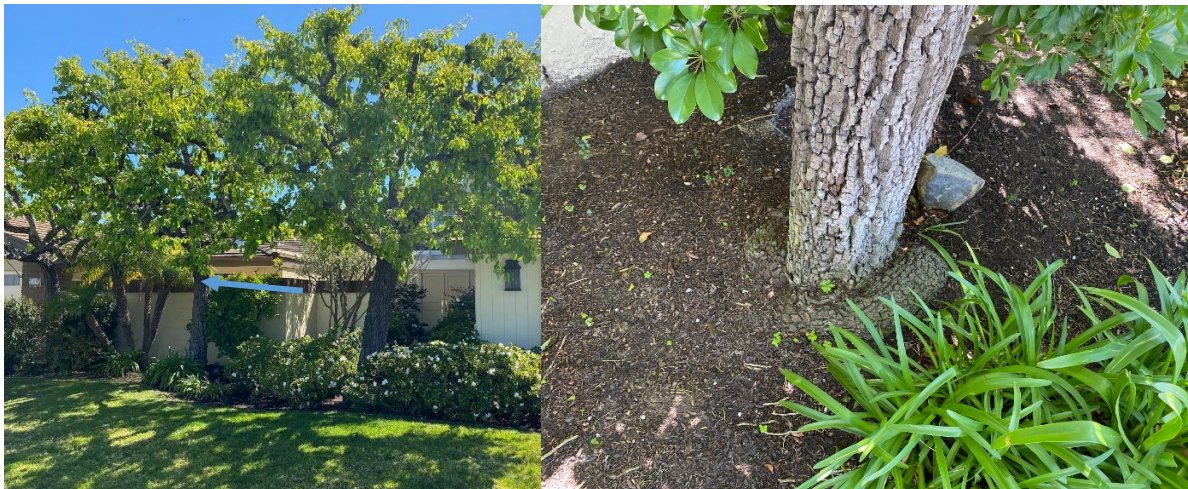
Carrotwood tree in between 20/22 Skysail Dr, tree is stable nothing of concern, signs of erosion on the front side, tree has established tension roots on the back end for stability.

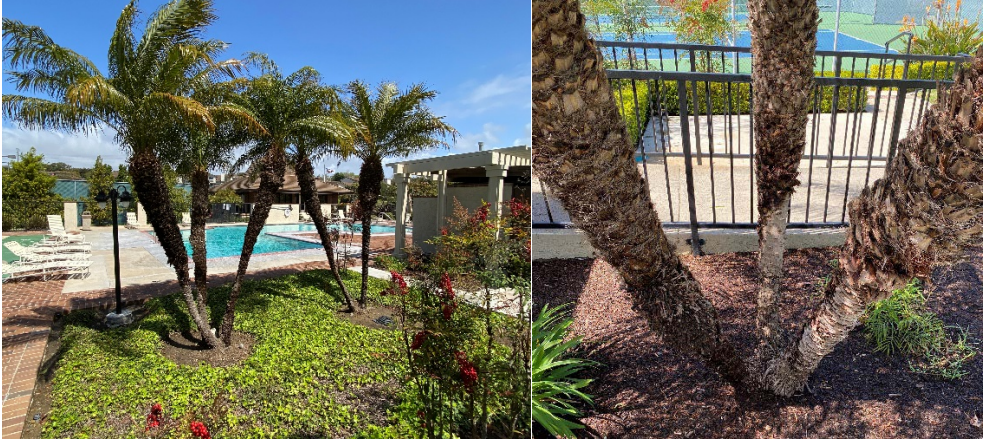
There has already been an existing lateral branch failure. During the site inspection, it was noted that the trunk flare has roots growing at the trunk union. As a result, these surface roots weaken the tree, increasing the possibility for failure. Recommendation for removal.
