## Jasmine Creek HOA

March 23, 2023

SUBJECT: Tree Risk Assessment

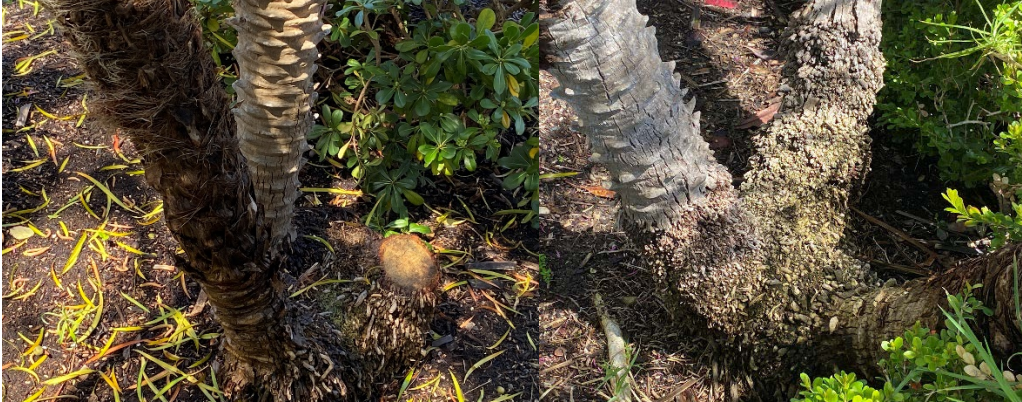
There has already been an existing lateral branch failure. During the site inspection, it was noted that the trunk flare has roots growing at the trunk union. As a result, these surface roots weaken the tree, increasing the possibility for failure. Recommendation for removal.

In conclusion, Pear trees along the slope of Breakwater Dr, recommendation to remove; also recommending no replacement trees - not warranted due to the views. Trees planted along the slope will always be subjected to being topped and or pollarded. Secondary issues are always a higher potential following that type of pruning. The remaining pears throughout the community are currently not showing visible signs of blight. The Pygmy palms, given the current lifespan and high target area, recommendation for removal. We will continue to monitor their status and if there is anything to report, it will be brought up to your management team. 25 Mainsail (Monitor), 34/32 White Water Dr (Recommend Removal), 20/22 Skysail Dr (No Action Needed).
